Home Inspection Report

124 Sample Drive, New Orleans, LA 70034

Monday October 22, 2018

Cypress Home Inspections LLC
42747 Scarlet Cir
Hammond, Louisiana 70403
(985) 662-4146
cypresshomeinspections@gmail.com

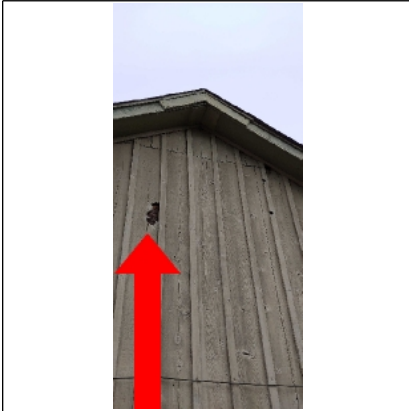
Damage to wood siding. Possible moisture and pest entry point. Recommend repairs.

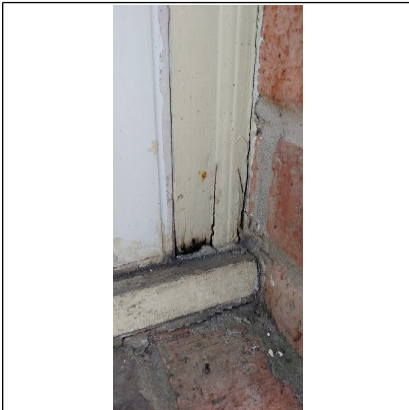
Wood trim around window is showing signs of deterioration. Possibly due to poor caulking/sealant.

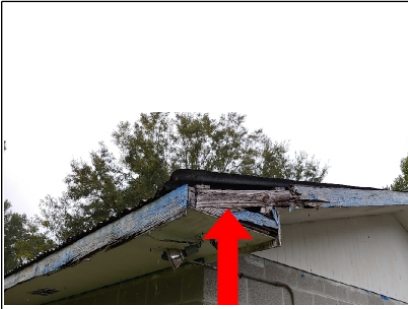
Fascia board has excessive deterioration. Moisture and wood destroying insect damage.

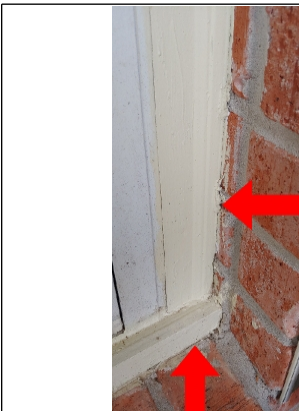
Recommend caulking to seal all openings to prevent moisture intrusion.

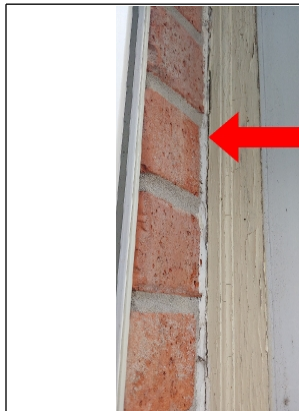
Recommend caulking to seal all openings to prevent moisture intrusion.

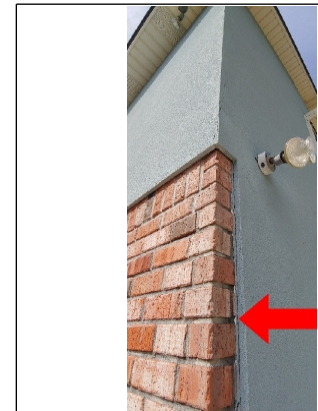
Recommend caulking to seal all openings to prevent moisture intrusion.

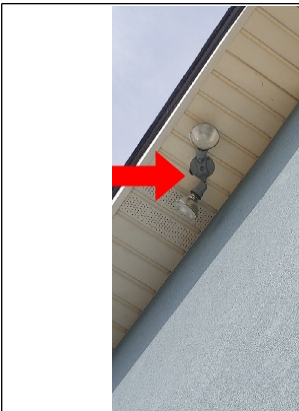
Recommend caulking to seal all openings to prevent moisture intrusion and pest entry.

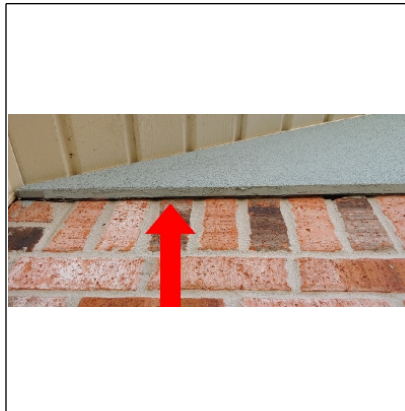
Recommend caulking to seal all openings to prevent moisture intrusion and pest entry.

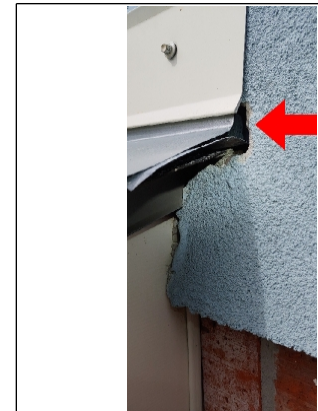
Recommend caulking to seal all openings to prevent moisture intrusion and pest entry.

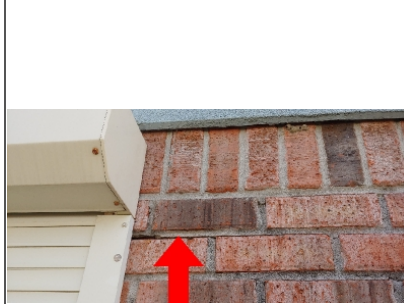
Brick-and-mortar separation possibly due to rusting lintel.

Recommend removing as much rust as possible, priming / painting to prevent further deterioration.

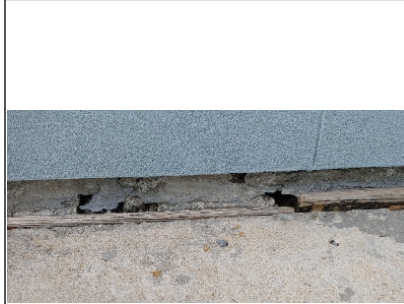
Holes in slab foundation. Recommend filled with concrete.

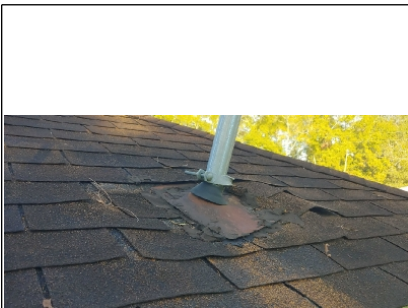
Damaged shingles around Weatherhead service entry. Possible moisture entry point. Recommend repair.

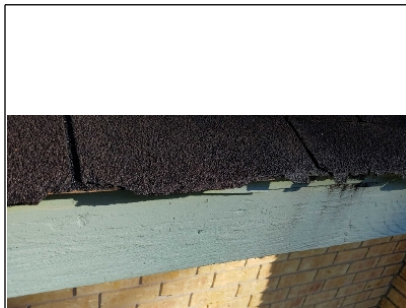
Damaged shingles before drip edge. Possible moisture entry point. Recommend repair.

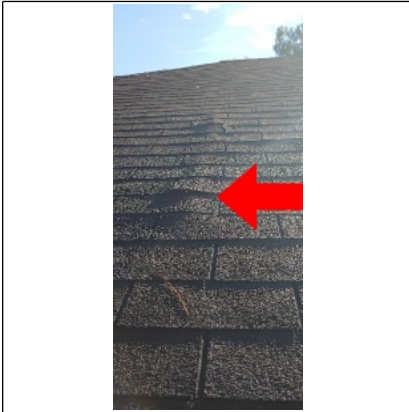
Curling shingles are evidence that the roof is near or at the average life span. Budget for roofing replacement materials in near future.

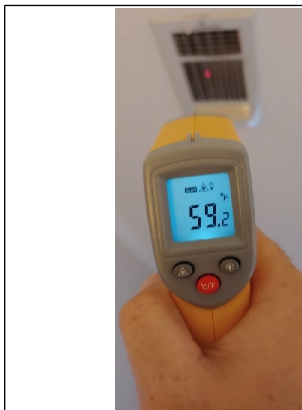
59 degrees observed at supply.
11 degree differential. Therefore
evaporator coil is functioning
properly.

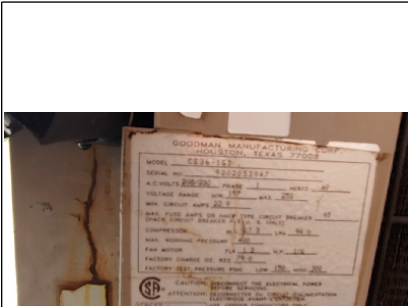
Exterior AC data tag.

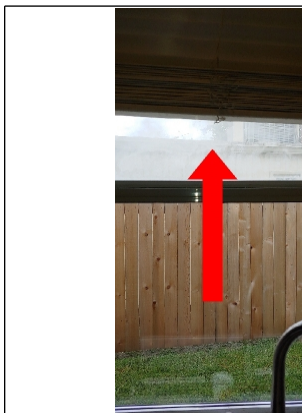
Broken seal on insulated glass window.

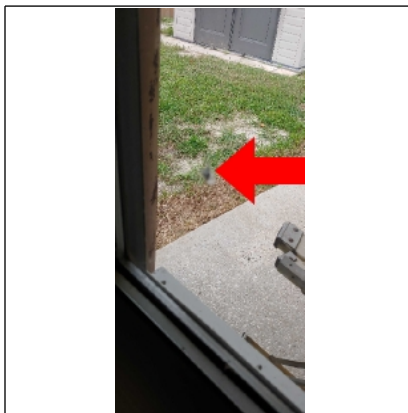
Cracked window glass.

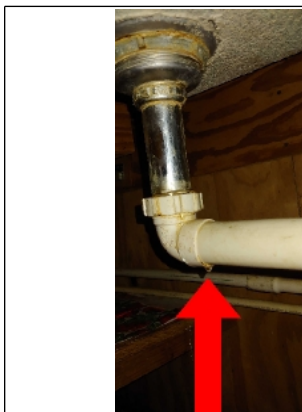
Leak underneath kitchen sink.
Recommend repair.

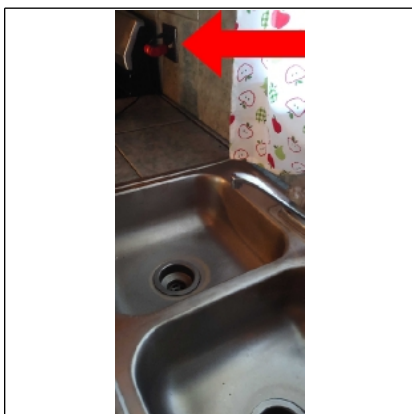
Recommend this receptacle replaced with a GFCI receptacle since it's near a source of water. Potential safety hazard.

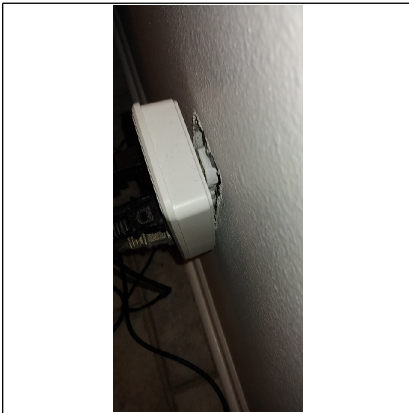
Missing electrical cover plate.
Potential safety hazard.

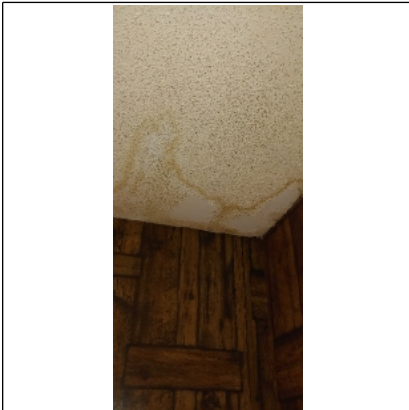
Moisture staining, active leak from attic side.

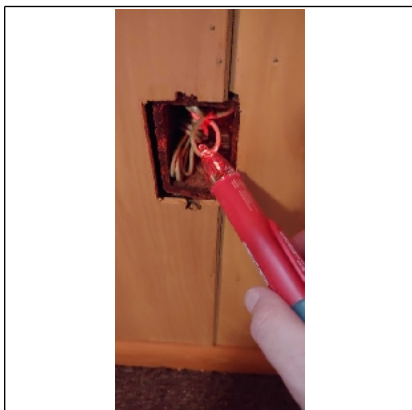
Missing receptacle outlet / hot exposed wires. Potential safety hazard.

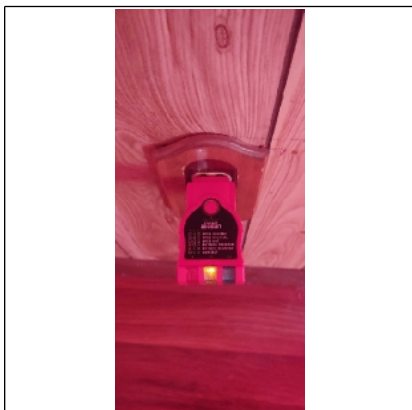
Ungrounded receptacles in bedroom. Potentially could harm appliances if lightning is in the area.

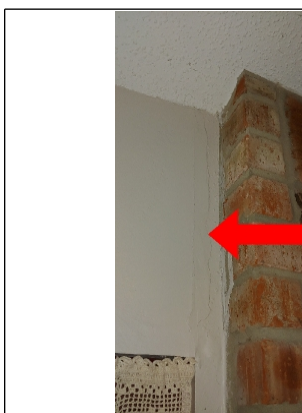
Recommend monitoring patchwork around interior chimney.

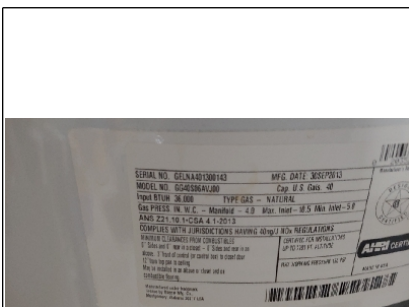
Water heater data tag.

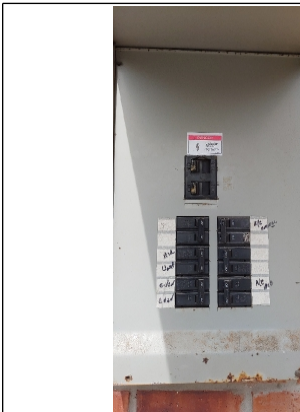
Recommend properly labeling all Breakers.
