Home Inspection Report

123 Sample Drive, Hammond, LA 70403

Tuesday October 9, 2018

Cypress Home Inspections LLC
42747 Scarlet Cir
Hammond, Louisiana 70403
(985) 662-4146
cypresshomeinspections@gmail.com

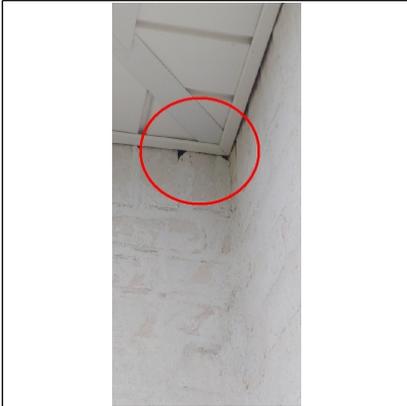
Incomplete mortar. Possible moisture and pest entry point.

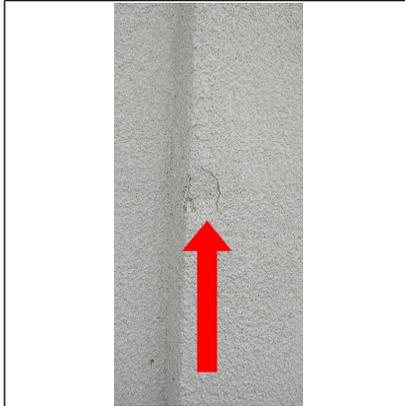
Damage to stucco by main entrance.

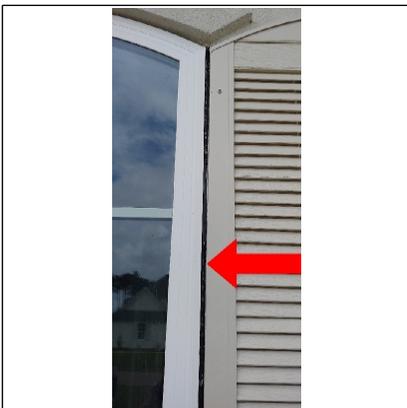
Vapor Barrier house wrap is exposed.

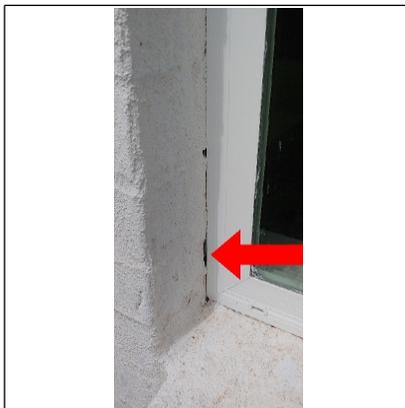
Incomplete mortar / caulking. Recommend sealing around all windows and doors.

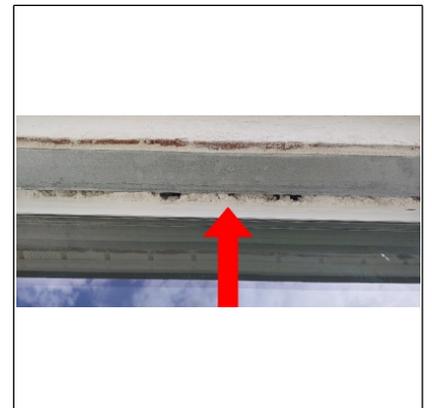
Incomplete mortar / caulking. Recommend sealing around all windows and doors.

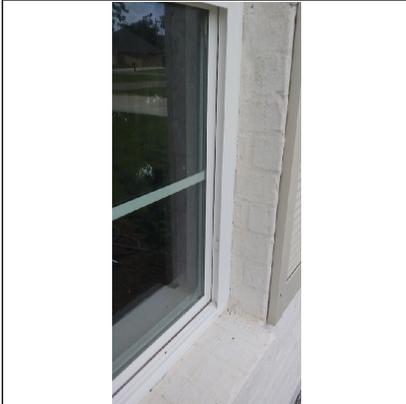
Missing screens threwout home.
Recommend all screens are
accountable for prior to closing.

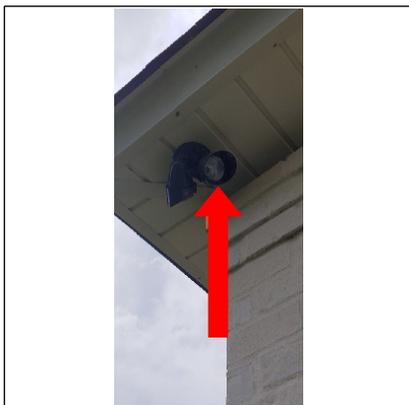
Recommend replacing missing light bulb and reevaluate for functionality. Repair or replace if needed.

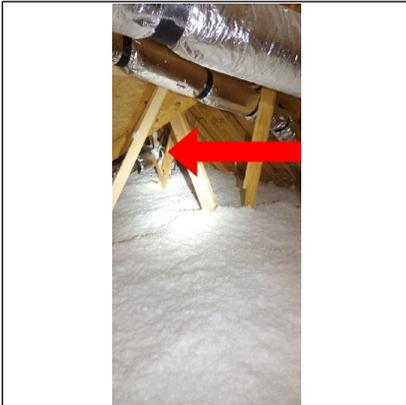
Limited visibility beyond this point due to lack of walking platform.

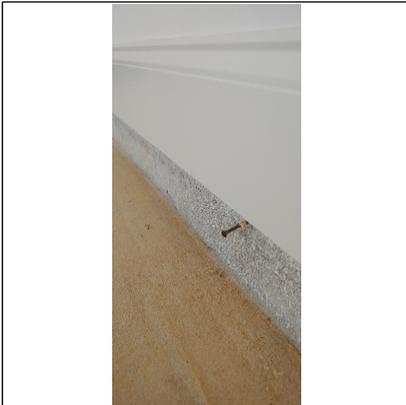
Recommend removing all screws that is sticking out. Potential safety hazard.

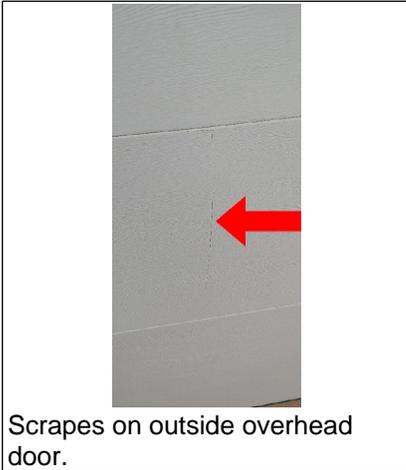
Scrapes on outside overhead door.

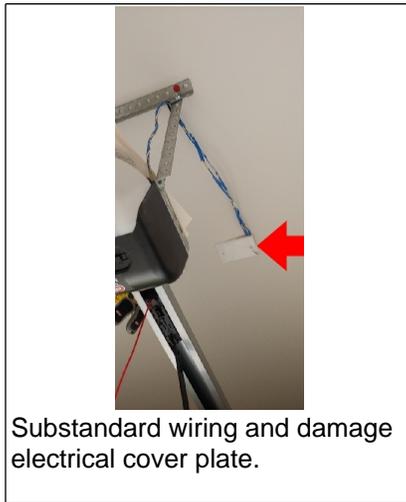
Substandard wiring and damage electrical cover plate.

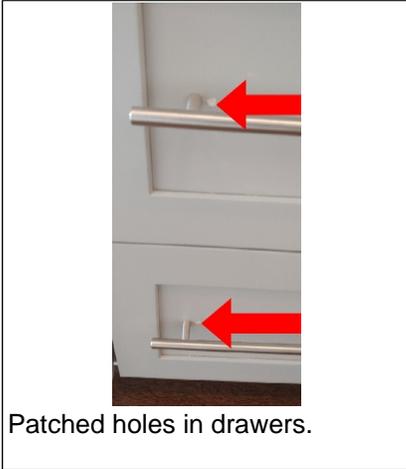
Patched holes in drawers.

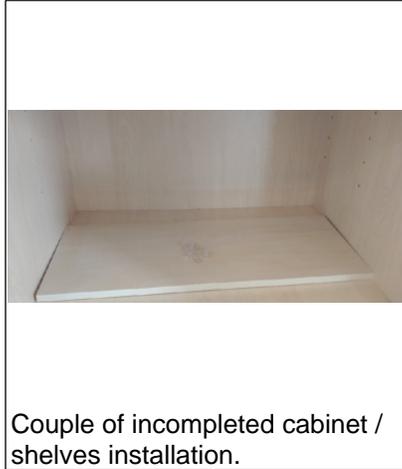
Couple of incomplected cabinet / shelves installation.

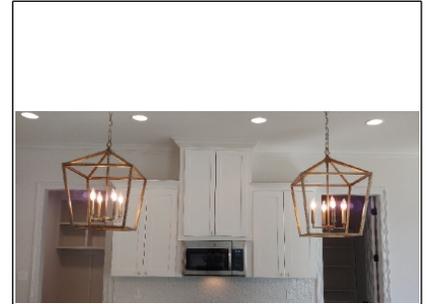
Hanging light fixtures are uneven.

Recommend repairing all loose hardware.

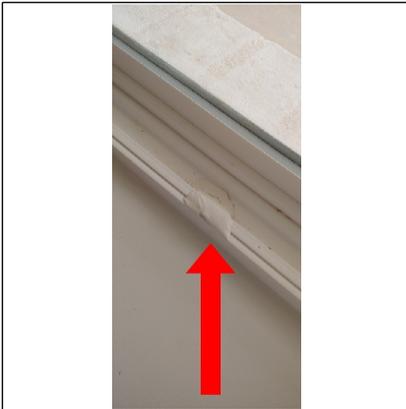
Recommend removing all unwanted drywall mud.

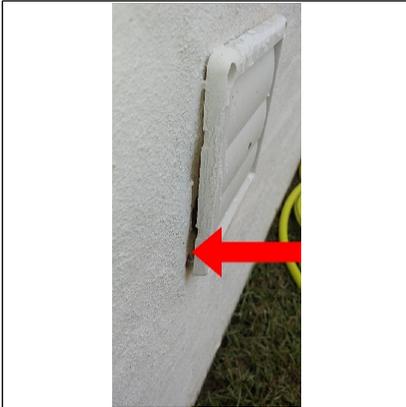
Recommend dryer exhaust screen flush with wall to prevent pest entry.

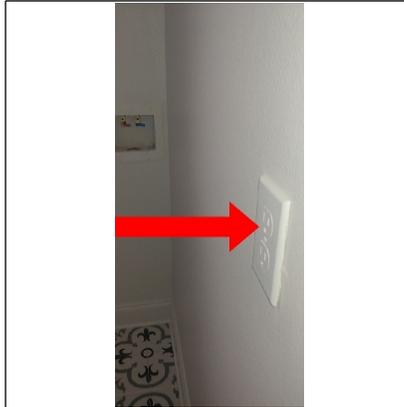
Recommend this receptacle replaced with a GFCI receptacle since it's near a source of water. Potential safety hazard.

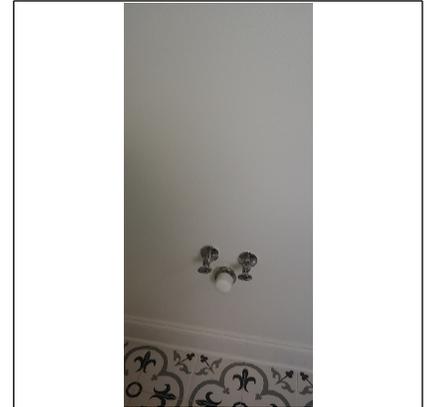
Sink is not installed.

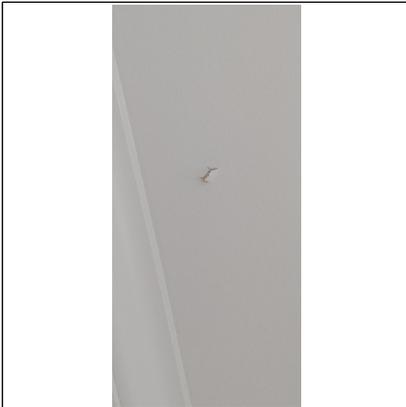
Damaged drywall observed at ceiling.

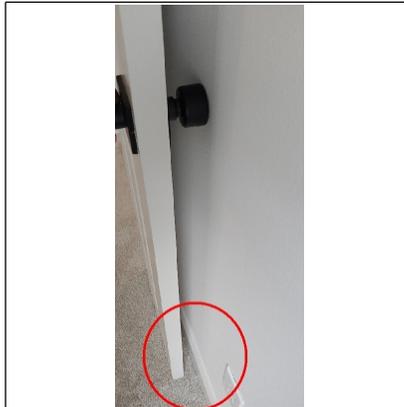
Bedroom to bathroom door is missing door stopper.

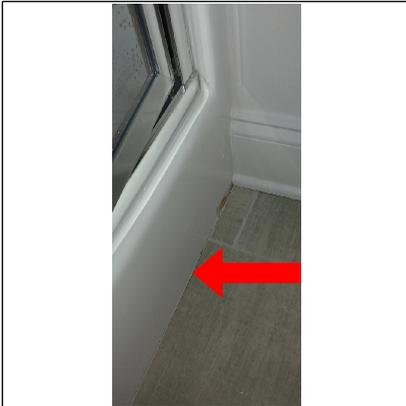
Recommend caulking to seal all openings to prevent moisture intrusion.

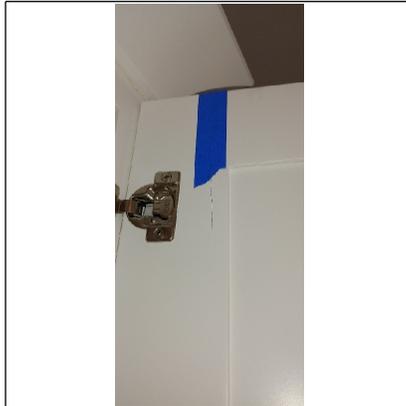
Damage Cabinetry.

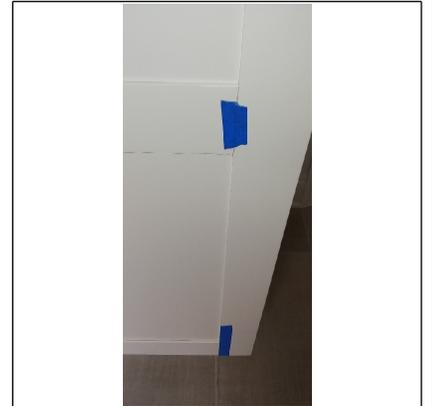
Damage Cabinetry.

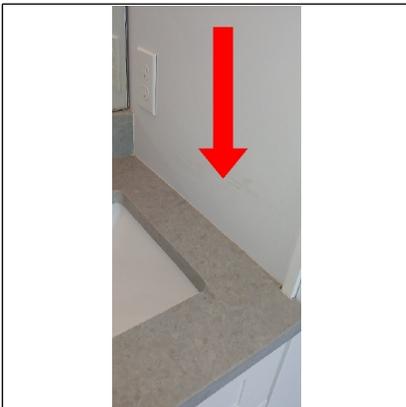
Recommend removal of any unwanted paint / dirt.

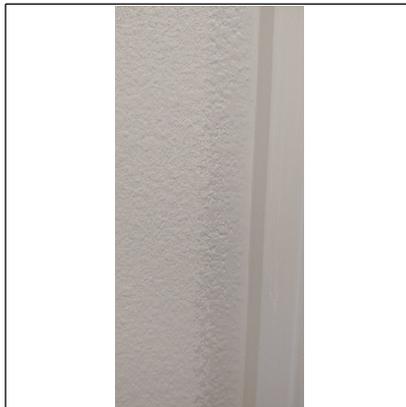
Unfinished painting threwout home. Paint around door trim is darker.

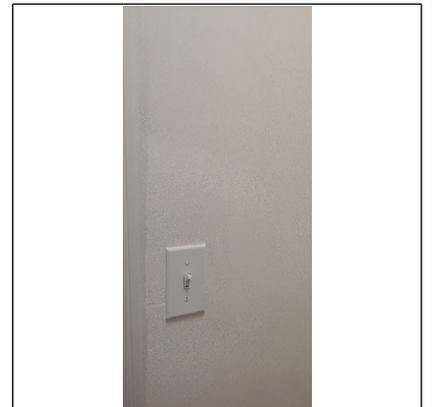
Texture and paint isn't consistent in bathroom closet.

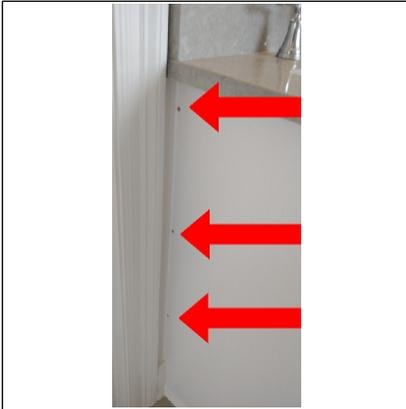
Exposed screw heads.

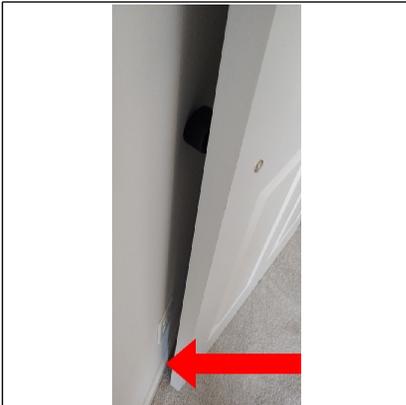
Missing door stop.

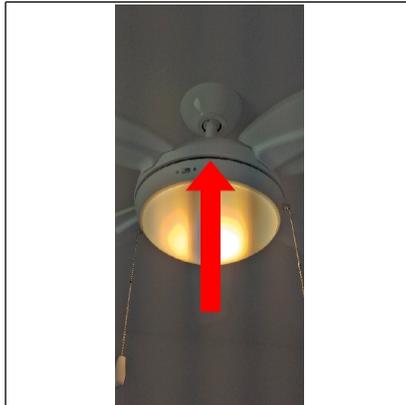
Slight wobble and noise observed at ceiling fan.

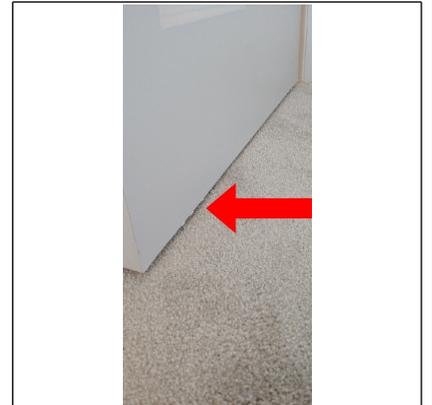
Rough edges observed at bottom of door.

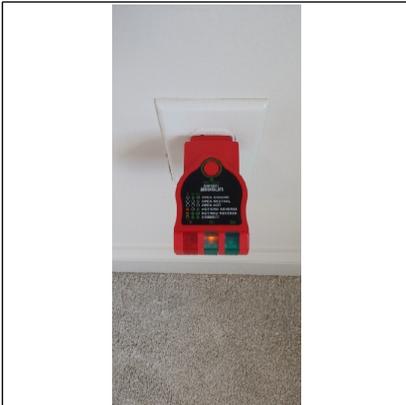
Every receptacle in this room is ungrounded except for one. Recommend all properly grounded to prevent damage to electrical devices.

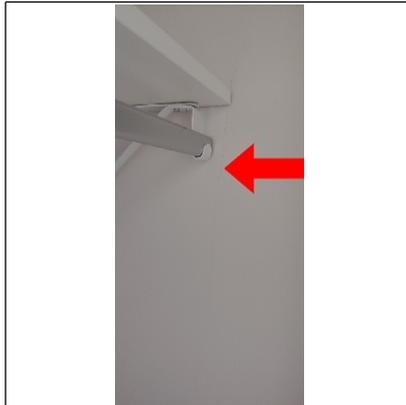
Damage to drywall.

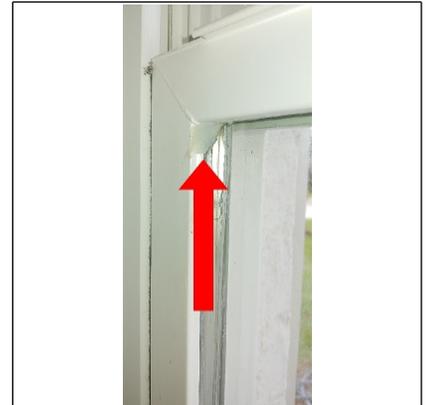
Silicone caulking should not be necessary for a brand new window.

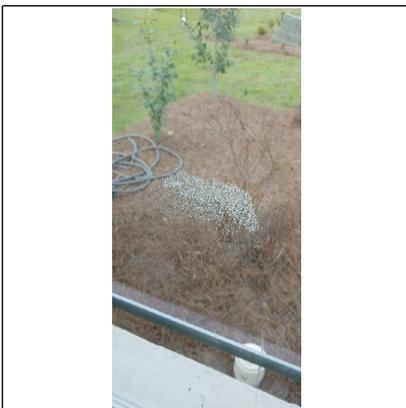
Recommend properly cleaning window.

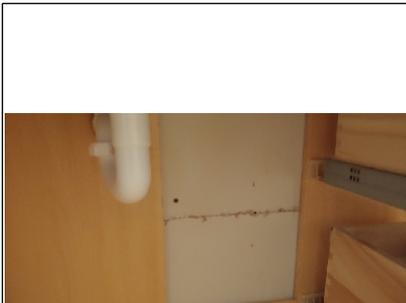
Damage to drywall underneath.

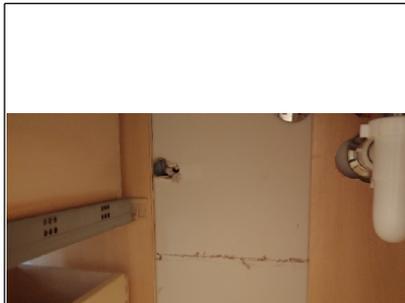
Damage to drywall underneath.

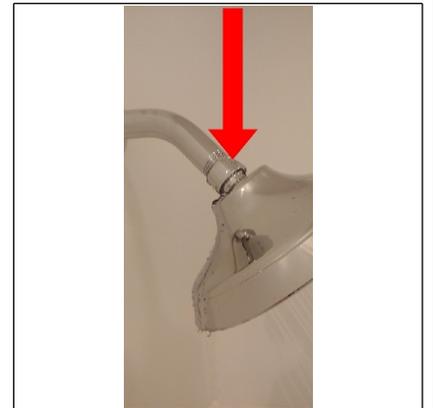
Leak observed at shower head.

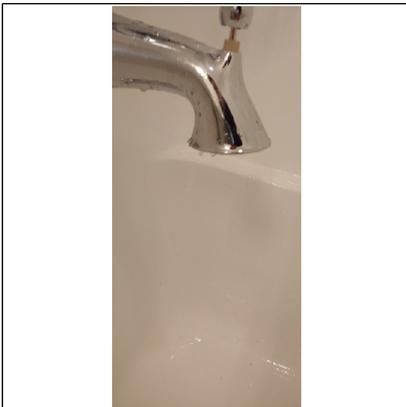
Tub faucet should NOT leak while shower is running.

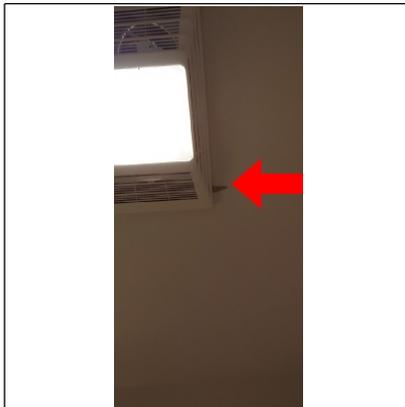
Damage to drywall.

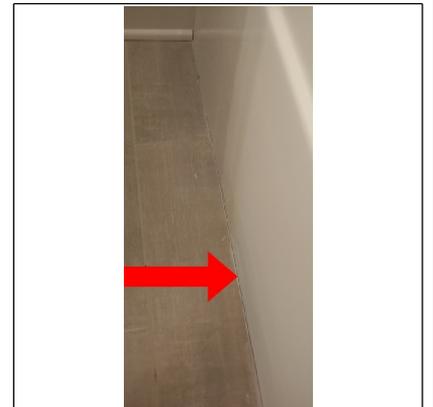
Recommend caulking to seal all openings to prevent moisture intrusion.

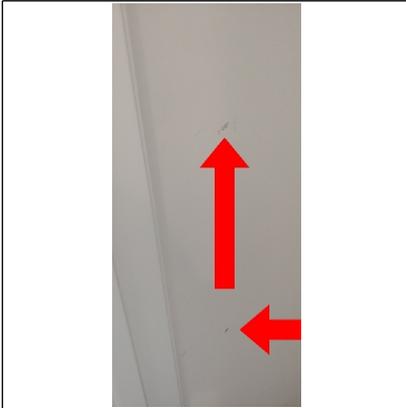
Unwanted paint observed in foyer closet.

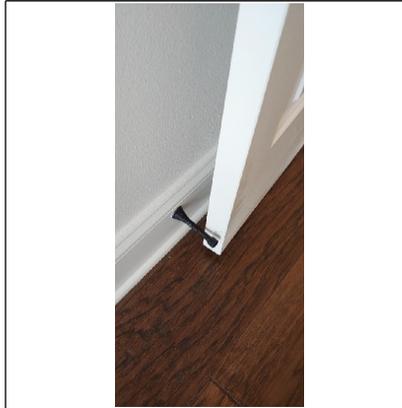
Door stopper is NOT properly installed.

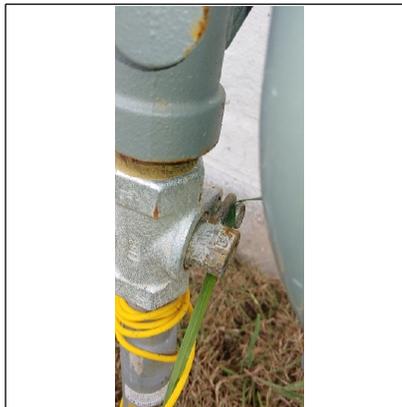
Fuel valve is locked in the off position.

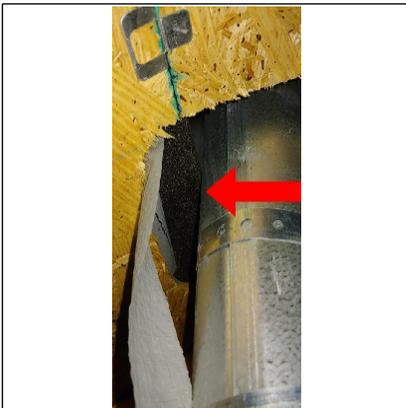
Vent Pipe (Gas) Improper clearance From Combustibles

Gas B vents recommend a 1 inch clearance from combustibles.

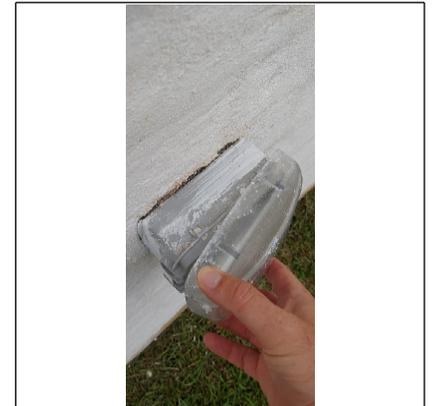
Receptacle cover is damaged.
